**A Preliminary Report on the Ground Survey of the 1950 USAF  
B-36 Crash near Mount Kologet, B.C.**

**Prepared by D. Davidge  
Environmental Assessment Officer  
Environmental Protection - Yukon Branch  
Environment Canada  
September, 1997**

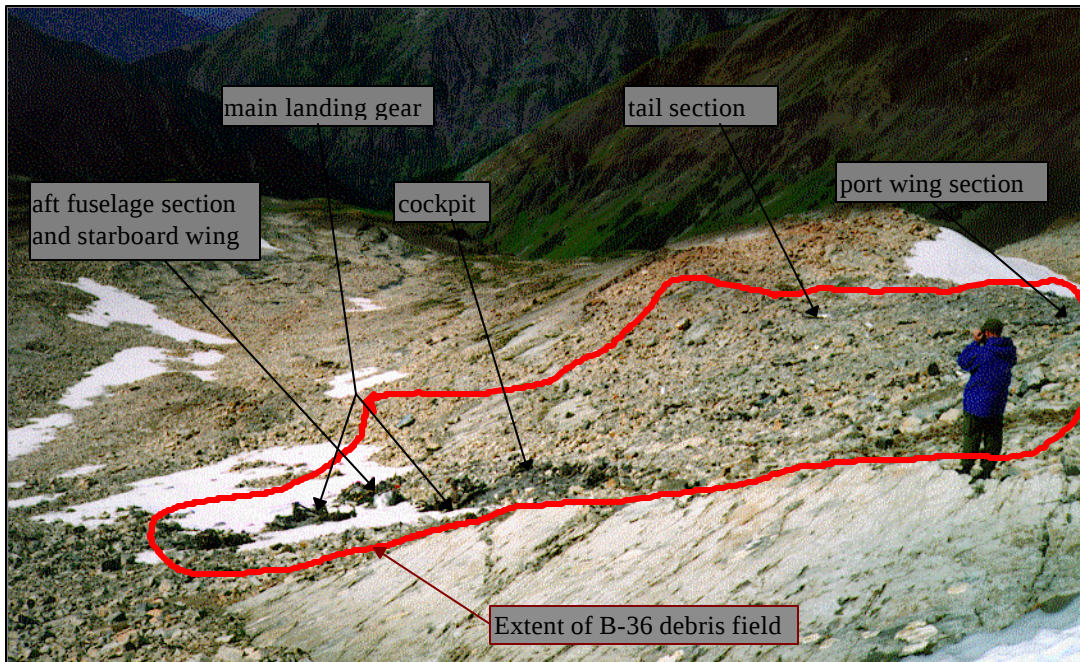
Aircraft wreckage was distributed over a large area along a steep westerly facing bolder and scree slope. Wreckage believed to be the tail section, the port wing and three engines were scattered across a small ridge several meters in elevation above the main fuselage wreckage (See Figure 1).

**Figure 1 View of the B-36 crash site**

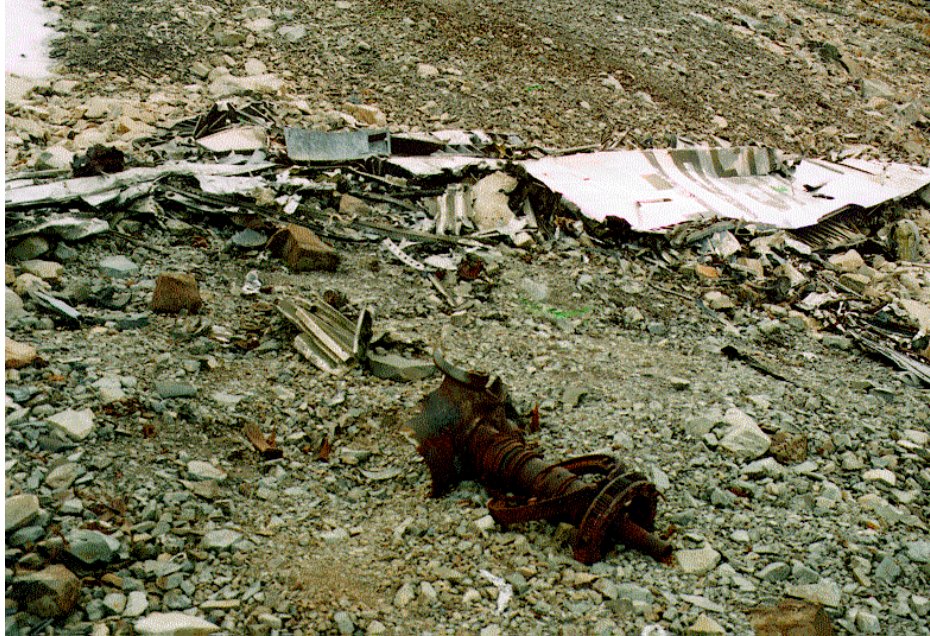
This area was completely free snow. The remains of the starboard wing and engines were located immediately adjacent to the main fuselage. Portions of the aircraft forward of the wings including the main landing gear, forward bomb bays and cockpit appeared to have been completely destroyed by a fire, no doubt caused by the impact of the crash. Items such as two of the port engines, portions of the port wing and a 20mm gun turret were probably demolished at a later date in 1954 by the USAF crash site

investigation team. Evidence of demolition by high explosives and the presence of unused explosives was found on site (see Figure 2, and 3 ).

**Figure 2 Destroyed port engine**

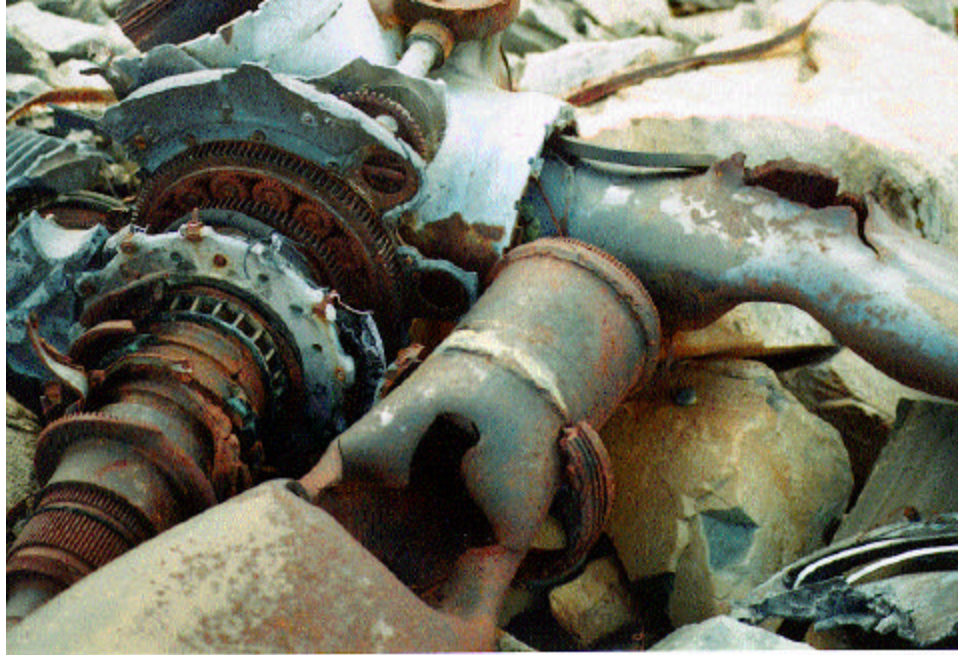
**Figure 3 Evidence of demolition on propellers**

Pieces of the engines, wing and turret that were demolished with high explosives were found scattered a considerable distance from the wreck site, in some cases up to 500 meters. A section of the aircraft aft of the wings including portions of the rear bomb bay, several engines and three 20mm twin gun turrets was found to be relatively intact (see Figures 4 and 5).

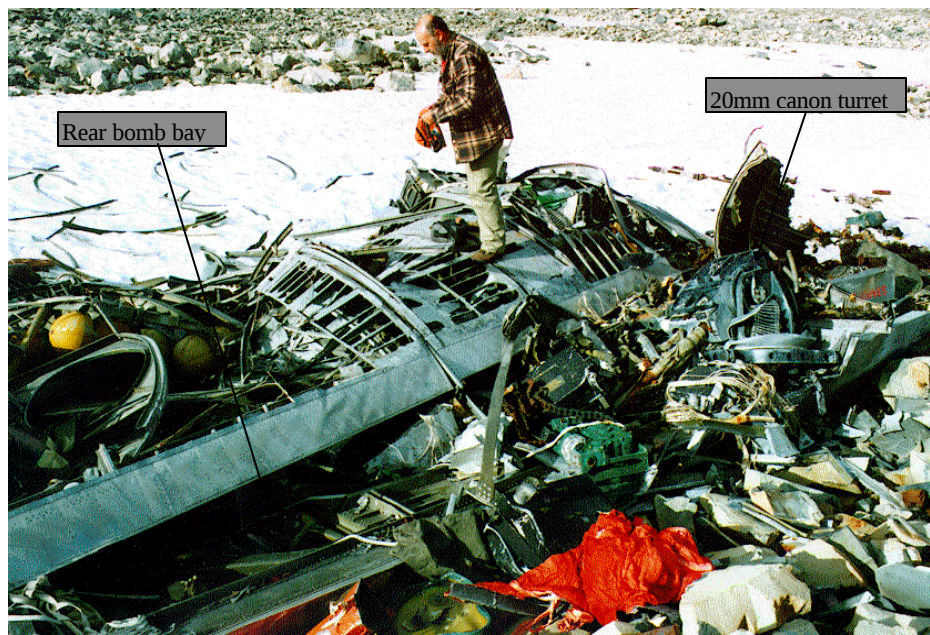
**Figure 4 Fuselage wreckage (aft section)**

The fuselage portion of these sections of the aircraft appears to be inverted and almost collapsed upon itself but there is no evidence of fire or demolition with high explosives. This area of the crash site was still partly inundated with snow up to 2m deep. A number of items such as personal belongings, survival equipment, instrumentation, oxygen cylinders and engine covers were found in the fuselage. In addition to this an aluminum case label in red with “Explosives” was also found, however, for safety reasons, was left undisturbed for the moment.

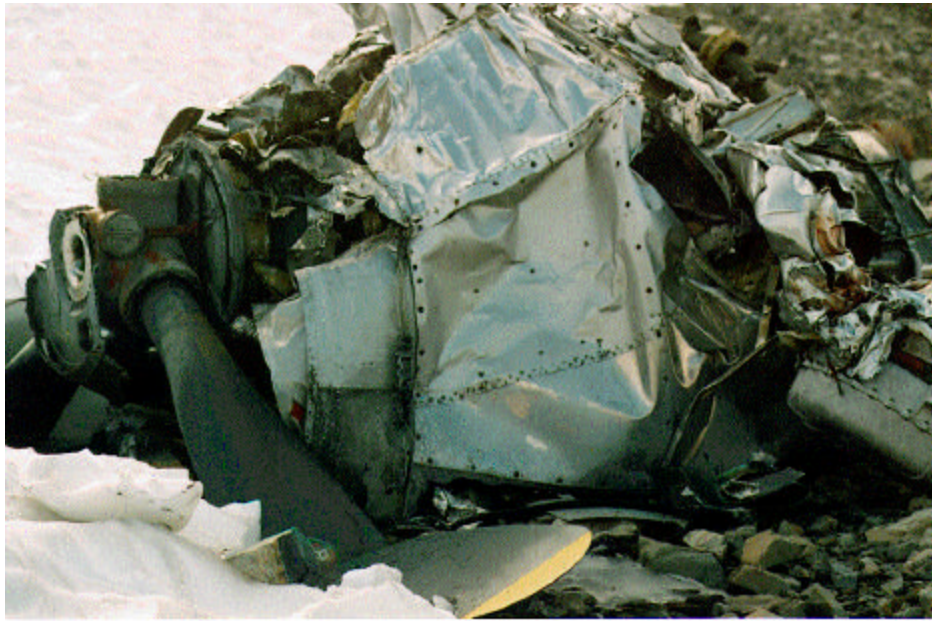
**Figure 5 One of three Port engines**

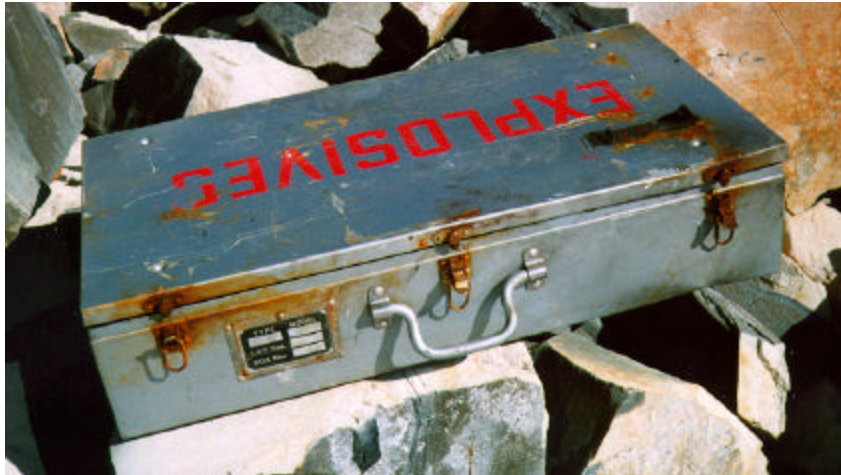
The aluminum "Explosives" box previously mentioned was investigated further by DND personnel. They found it contained 4 of 36 electronic type detonators. The missing 32 detonators are believed to have been used to arm a bomb being carried by the flight in February, 1950. The case and enclosed documentation identified the detonator components were intended for use in a Mk IV device (see Figures 6,7,8, 9 and 10).

**Figure 6 Aluminum Explosives Box**

A small number of unexploded 20mm canon shells from the B-36, small arms rounds, the mark IV detonators and the high explosives left by the USAF crash site investigation and demolition teams in 1953 and/or 1954 are considered to be a safety hazard. These findings will be reported by Lt. David Knight to the DND Explosives and Ordinance Demolition (EOD) group to address disposal options.

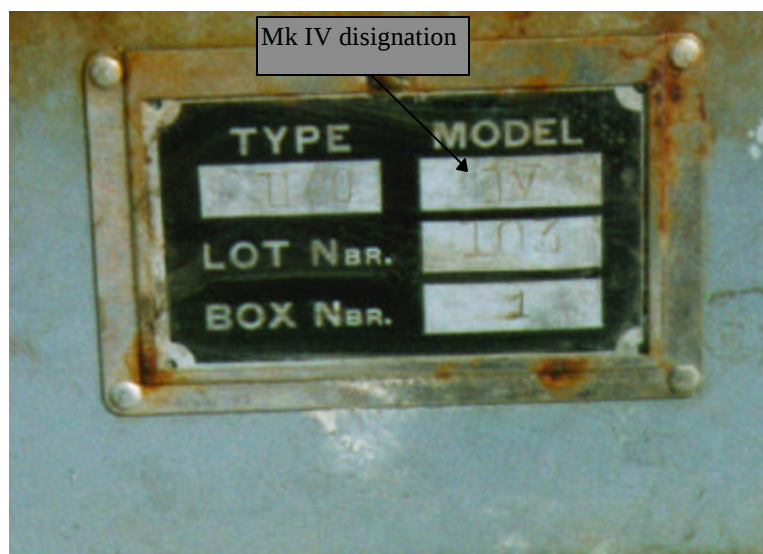
**Figure 7 Identification label for Mk IV components**

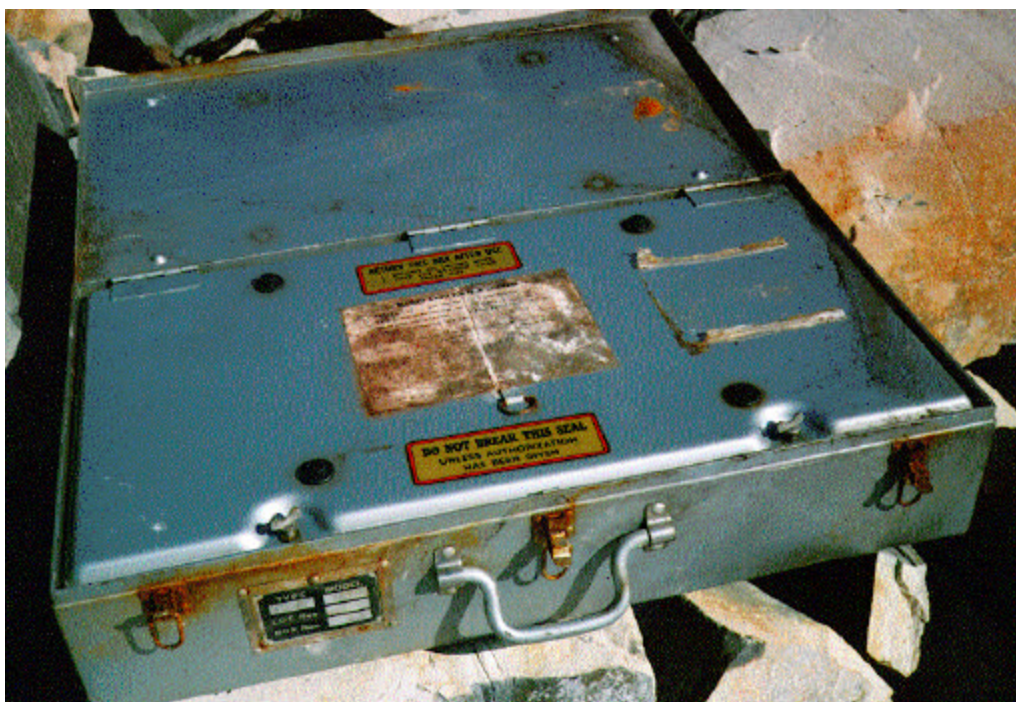
Figure 8 Inner lid on aluminum "Explosives" box

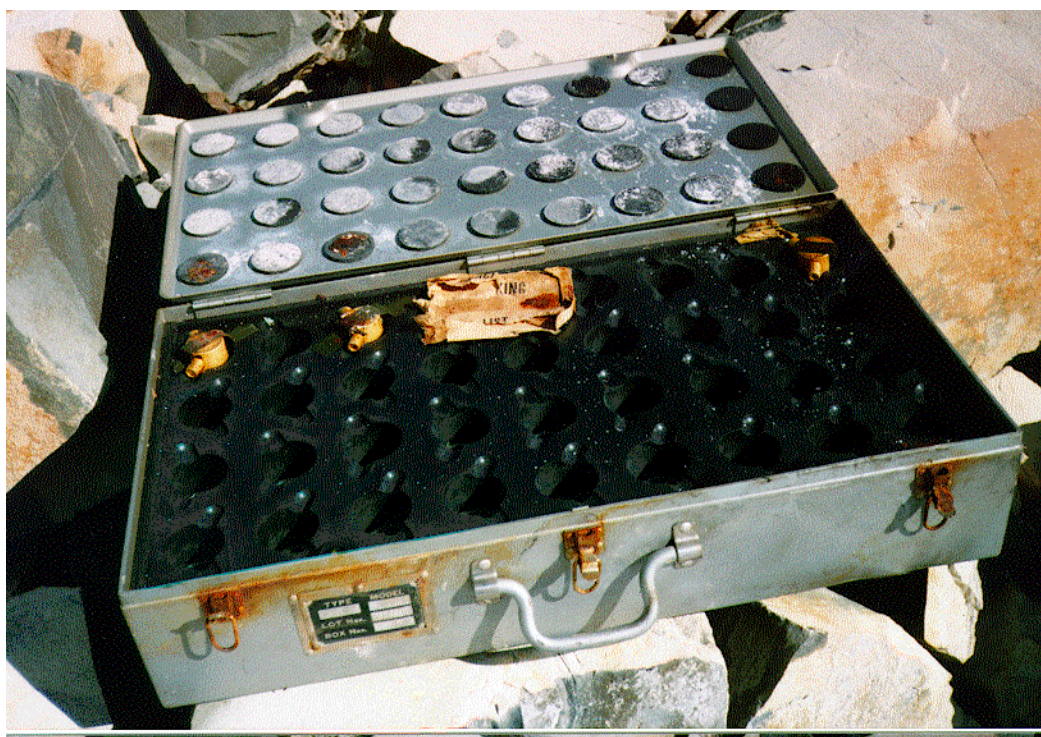
Figure 9 Contents of the aluminum "Explosives" box

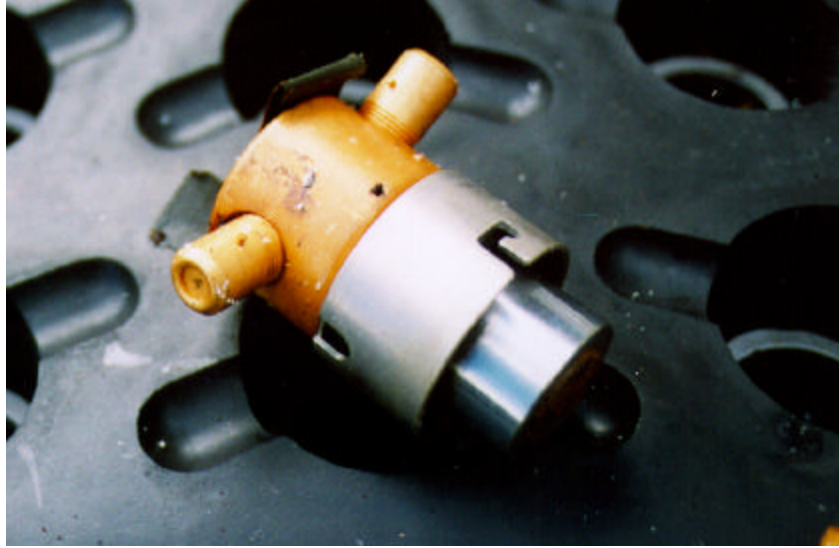
**Figure 10 One of four spare Mk IV detonators**

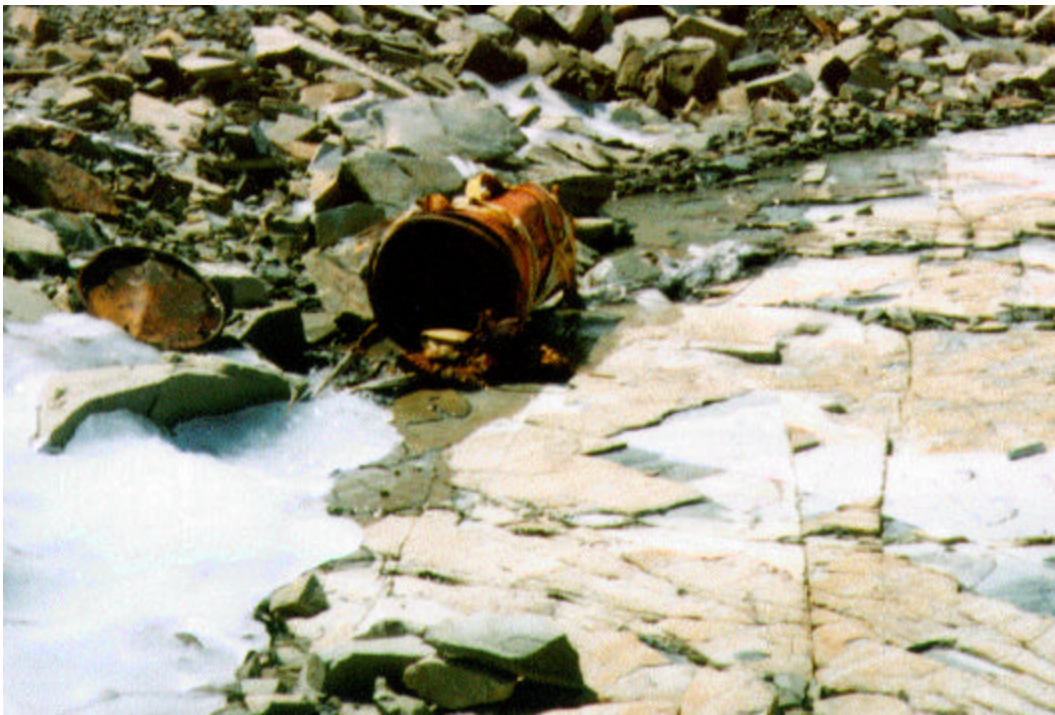
The surrounding area outside of the main crash site was searched for ordinance and other debris. DND personnel located a 60 to 80 litre sized metal canister (yellow in color) that still contained a full load of individual explosive charges (see Figure 11).

**Figure 11 Abandoned canister of un-used high explosives**

The metal canister was still attached to a parachute and appeared to have not been opened until this visit. We concluded the explosives were probably dropped in the fall of 1953, became covered in snow and were not located in 1954 by the second crash investigation team the USAF sent in. Consequently the explosives remained undetected until this visit.
